FERRY SAFETY INVESTIGATION

ENGINE ROOM FIRE ON BOARD *FANTASEA SPIRIT*
KISSING POINT SYDNEY HARBOUR

8 MAY 2016

OTSI Reference 04733

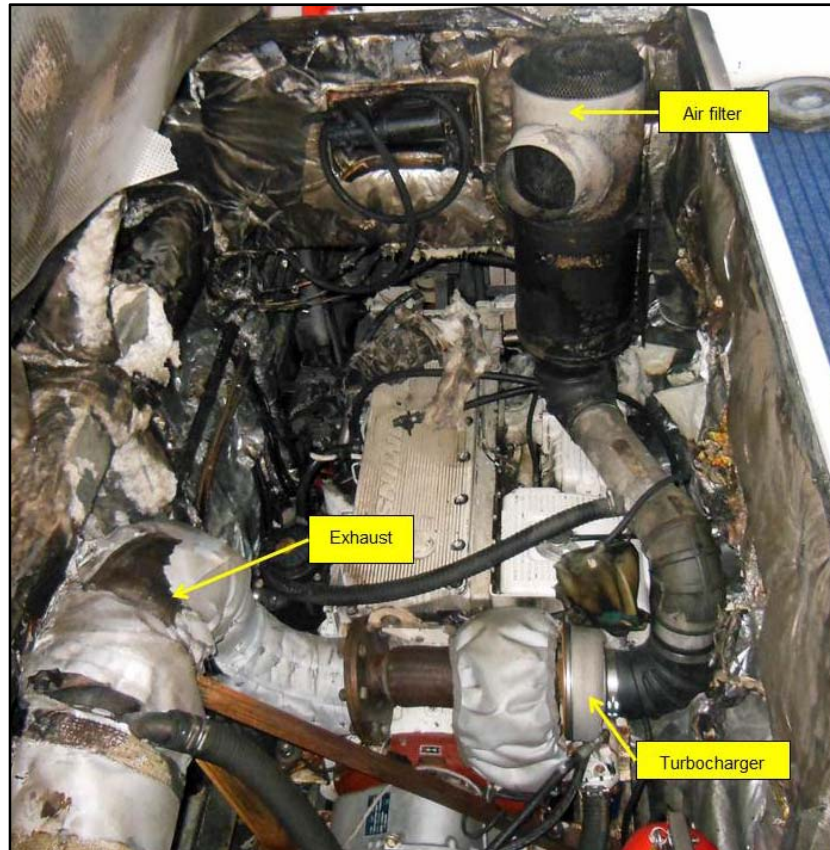
Photograph 2: Damage to port engine room

- 2.1 Damage was restricted solely to the port engine room of the ferry. The port engine air intake filter had received fire damage. The port cooling reservoir, sullage pump and wiring loom in close proximity to the air intake filter had been destroyed by fire. (See Photograph 2)

- 2.2 Additionally, there was fire damage to the exhaust pipe, exhaust lagging and a hose feeding engine gas from the rocker cover to the air intake near the turbocharger. The engine gearbox and turbocharger were intact, although there was minor wiring damage close to the exhaust and air filter.

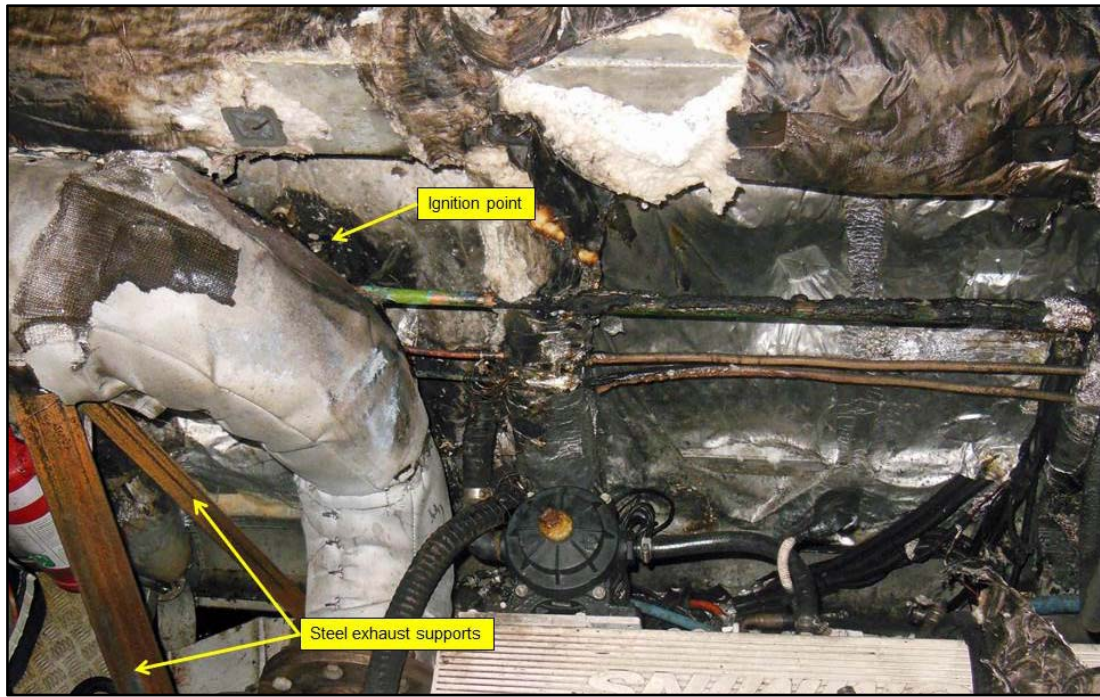
Photograph 3: Fire damage near exhaust

- 2.4 An area between the exhaust riser and the port side of the engine room was identified as the most likely ignition point of the fire. Examination of the lagging around the exhaust closest to the port side revealed that the lagging had suffered fire damage (See Photograph 3).

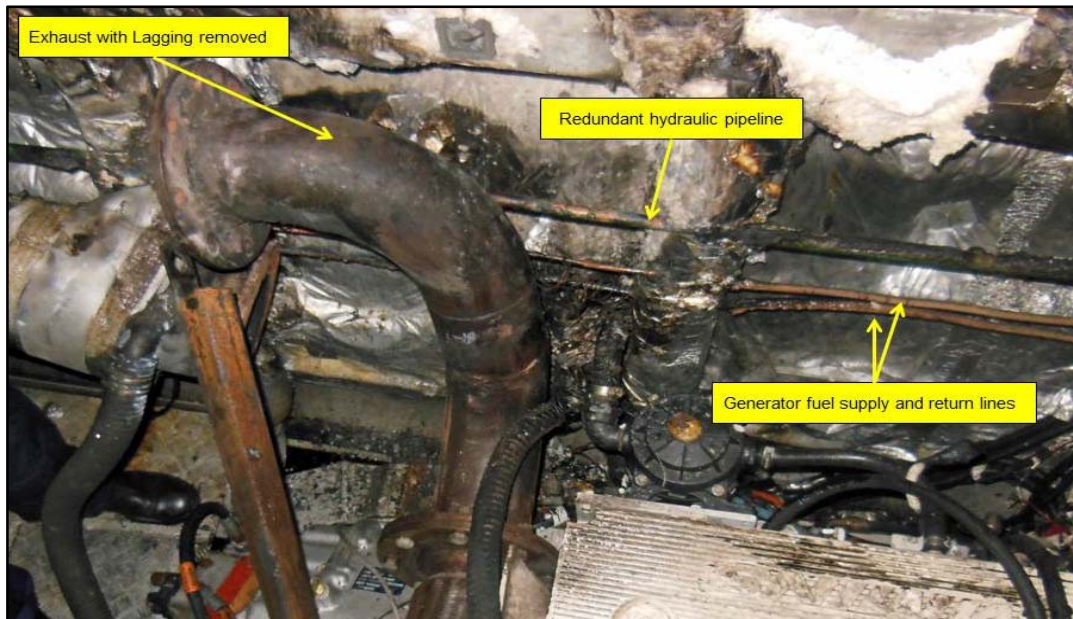
Photograph 4: Exhaust lagging removed

- 2.5 The engine exhaust riser is supported by a steel angle-iron frame. Examination revealed that one of the supports of this frame was broken at its base. This had allowed the exhaust pipe to displace laterally and rest against the port side of the engine room. It would have been difficult to detect the broken support without physically removing the exhaust system.
- 2.6 The unrestrained exhaust pipe had contacted three pipes mounted on the port side of the engine room (See Photograph 4).

- 3.4 Since the fire, the operator has removed the redundant hydraulic pipeline and repaired the exhaust support. The operator has checked all vessels in their fleet to ensure the correct installation of fire suppression cylinders. The operator has changed their asset management procedures related to fire suppression systems.
- 3.5 The operator, in conjunction with Fire and Rescue NSW, carried out a fire response exercise to improve ferry fire emergency response practices.

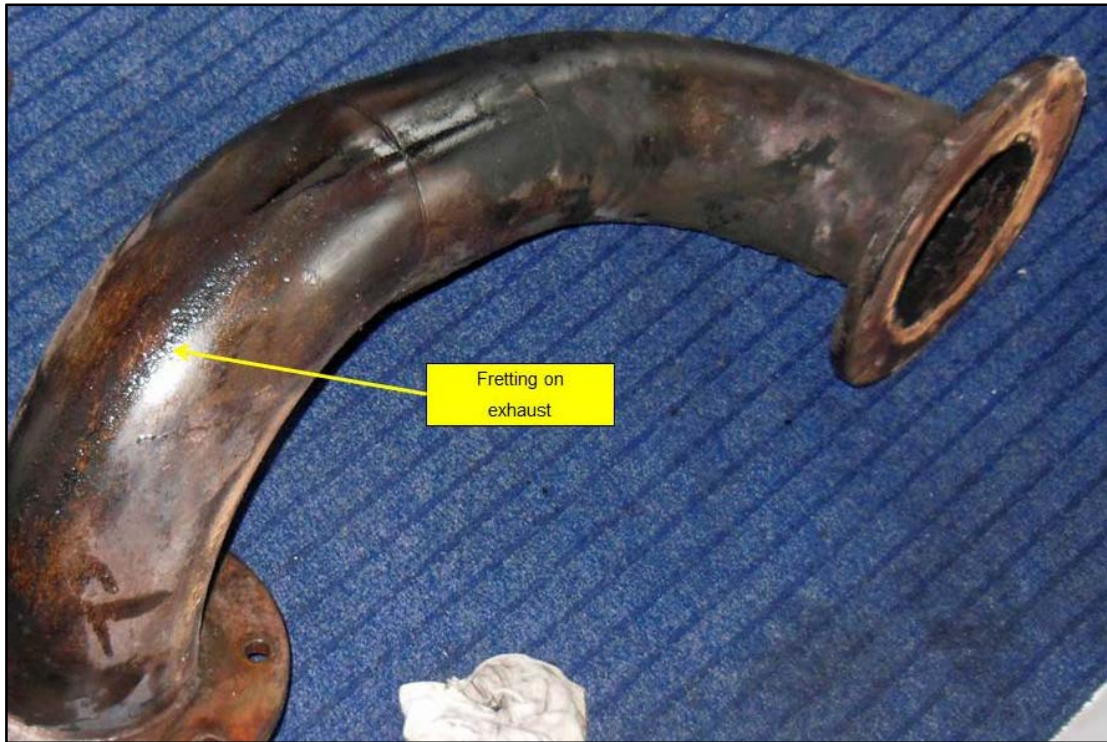
Photograph 5: Removed section of exhaust

- 2.7 The two lower pipes were identified as the diesel fuel supply and the fuel-return for the generator in the port hull.
- 2.8 The third pipe, above the diesel lines, was identified as a redundant hydraulic steering line from a previously fitted steering control system. The hydraulic system had been replaced with an electronic control system, however; the redundant pipes had remained in place and still contained hydraulic fluid.
- 2.9 The raised section of the exhaust was removed to expose the redundant fuel and hydraulic pipelines for examination (See Photograph 5).

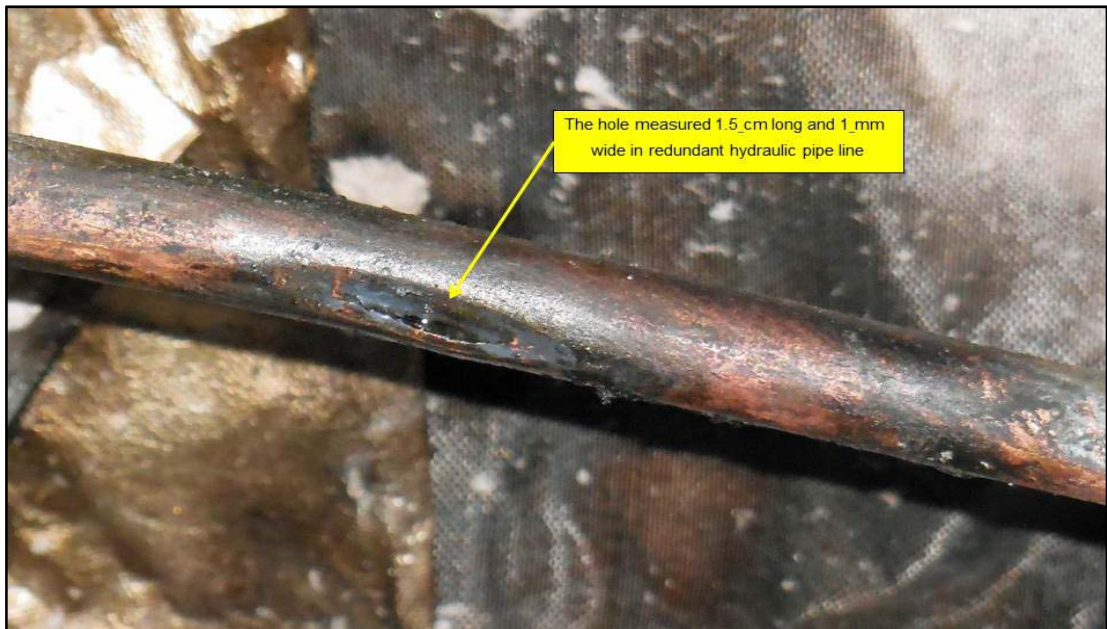
Photograph 6: Hole in hydraulic pipeline

- 2.10 A small hole was found in the redundant hydraulic pipeline and the hole corresponded with the contact by the exhaust pipe. Hydraulic fuel was still seeping from the pipe (See Photograph 6).

- 2.11 Further examination of the exhaust lagging in this area revealed it was saturated with hydraulic oil. It is most likely that the fire ignited when this lagging was heated by the exhaust.
- 2.12 The redundant copper hydraulic pipe had an 18mm nominal bore and was approximately 35 metres in length. The line contained hydraulic oil. When the steering system was replaced on 28 August 2015 the line had not been capped or the residual oil drained (See Photograph 7).
- 2.13 OTSI has estimated the volume of the redundant hydraulic line was approximately nine litres. However; it is unclear what was the total volume of the remnant hydraulic oil.

- 3.1 The fire in the port engine room was a direct result of an unsecured exhaust pipe wearing a small hole in a redundant hydraulic pipeline that contained hydraulic oil. It is most likely that the combination of the oil-saturated lagging and heat from the exhaust ignited the fire.
- 3.2 A secondary fire started when flames from the initial fire were drawn into the engine air intake and ignited the air filter element.
- 3.3 Action taken by the master and crew contained the fire, preventing significant damage, despite being hampered by the incorrect installation of the fire suppression cylinder.

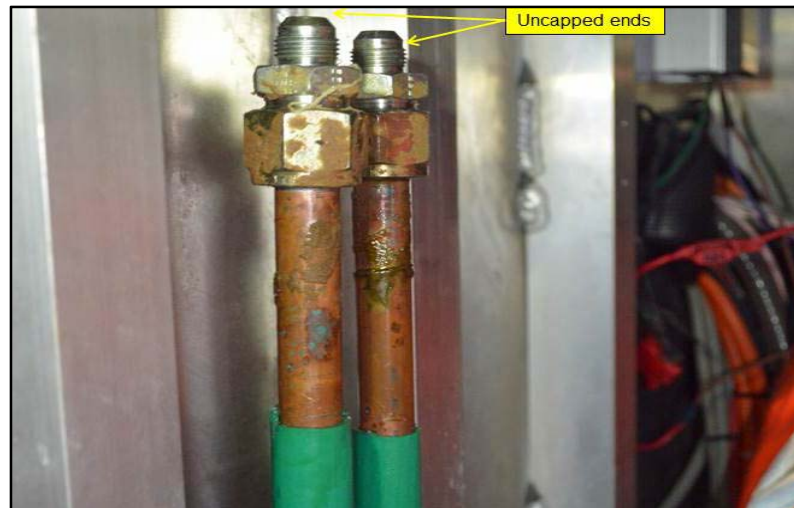
Photograph 7: Uncapped hydraulic lines under steering position

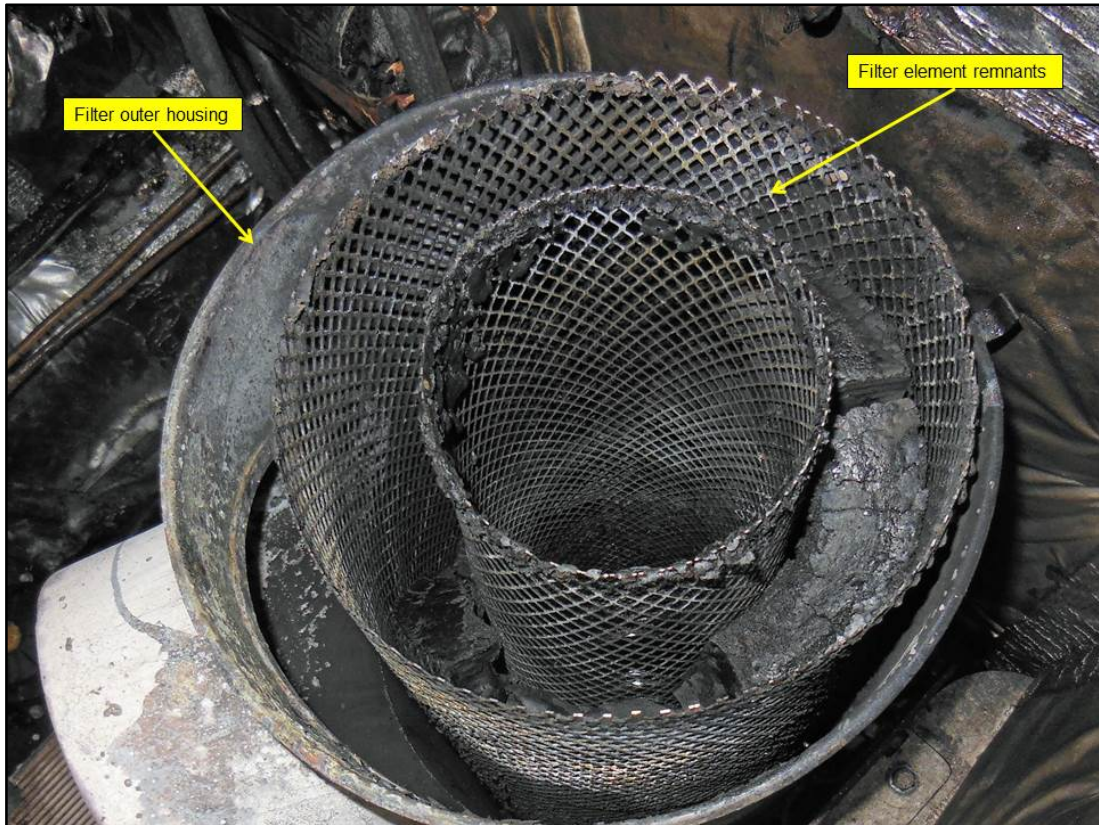
- 2.14 The investigation found there was additional damage within the port engine air filter assembly. It is likely the heat and flames from the initial fire were drawn into the air intake, igniting a secondary fire within the filter element.
- 2.15 Radiant heat from this secondary fire destroyed the coolant reservoir along with associated piping and wiring. In addition, the sullage pump mounted on the forward end of the engine room suffered fire damage (See Photograph 8).

Photograph 8: Fire damage to air intake filter

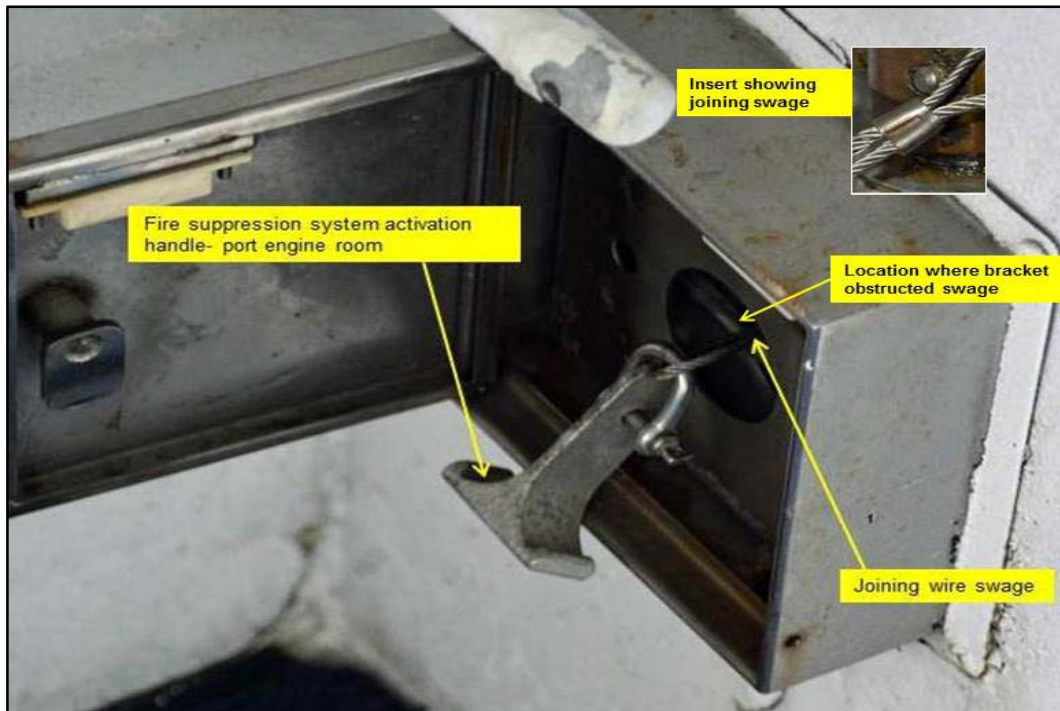
- 2.16 The failure of the fire suppression unit to activate when needed.
- 2.17 The fire suppression system's reservoir comprised of a 20 kg pressurised FM-200 gas cylinder. To activate the system, the operator is required to pull a release handle. When the release handle is pulled; a stainless steel wire attached to the handle runs over pulleys and activates a lever on the pressurised bottle, releasing the gas.
- 2.18 Examination of the port engine fire suppression system revealed that when the activation handle was pulled, the swage connecting the handle to the wire was fouling on the supporting brackets (see Photograph 9). A change of the direction of pull was required to free the movement. However, when the swage was clear of obstruction, the wire failed to activate the valve on the storage bottle.

Photograph 9: Port Engine room fire suppression activation

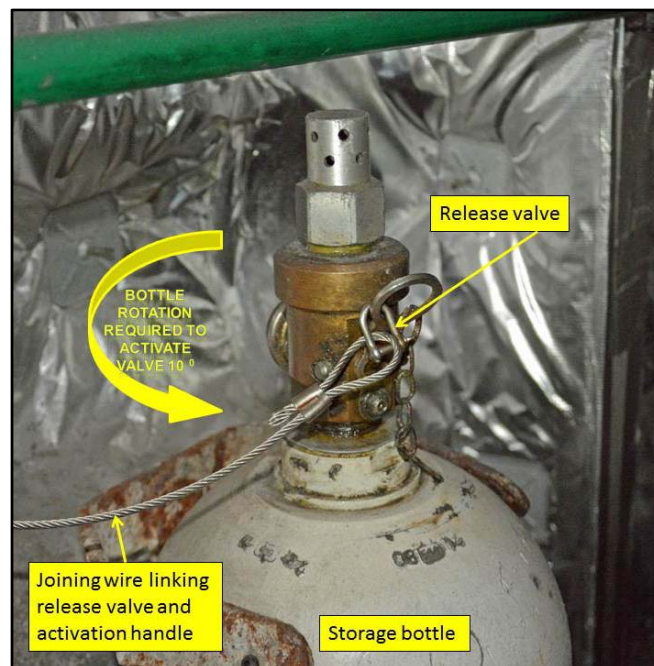
Photograph 10: Fire suppression cylinder

2.19 Examination showed that the direction of pull was working against the valve movement and not activating as designed (See Photograph 10). The release cable was free to operate as designed once the cylinder was rotated to the correct position. (see Figure 2).

- 4.1 Ferry operators to consider and control risks to operations that may be introduced from vessel modifications.
- 4.2 Ferry operators to ensure safety equipment, including fire suppression systems, is operational as designed.
