Nov 2020

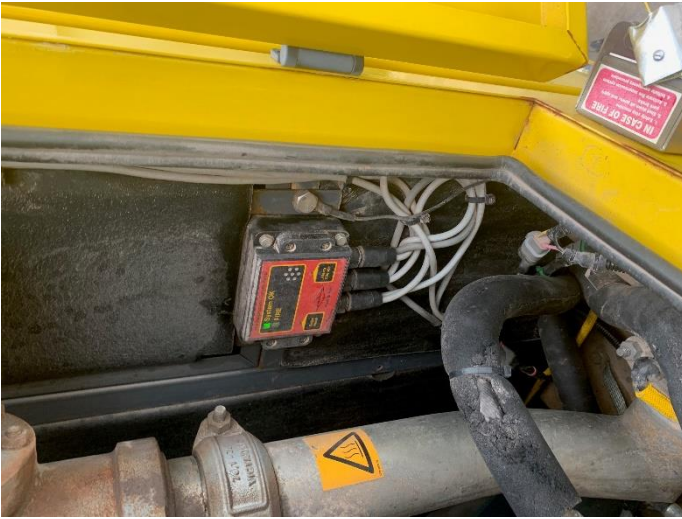
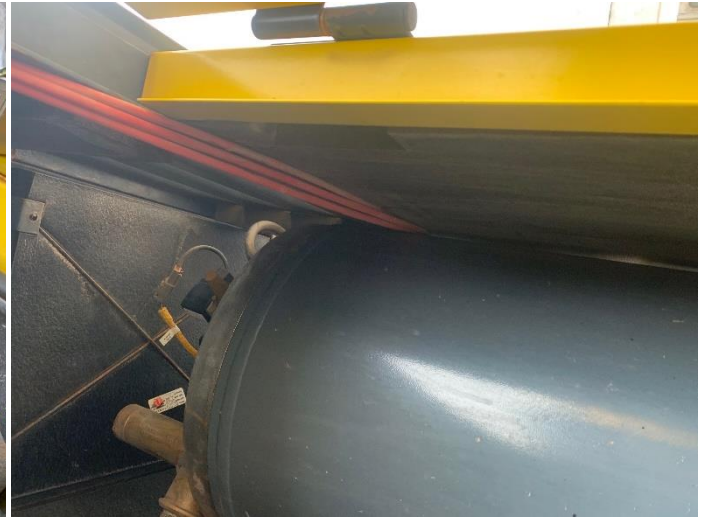
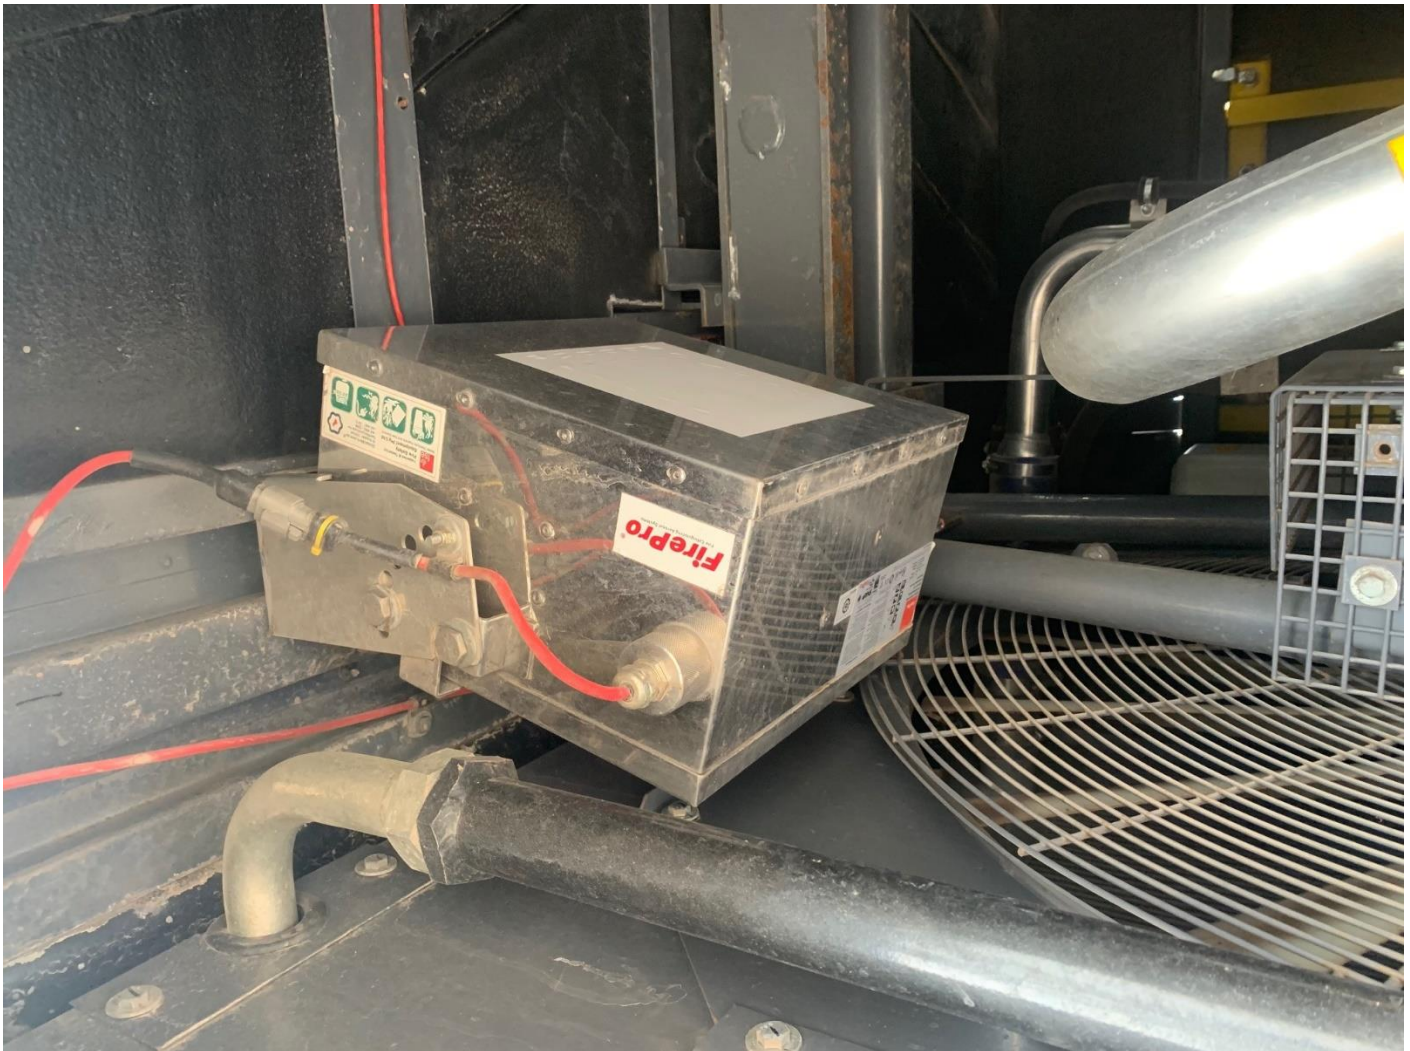
Issue to resolve

- Install PClips for cable throughout
