Feb 2021

Issue to resolve

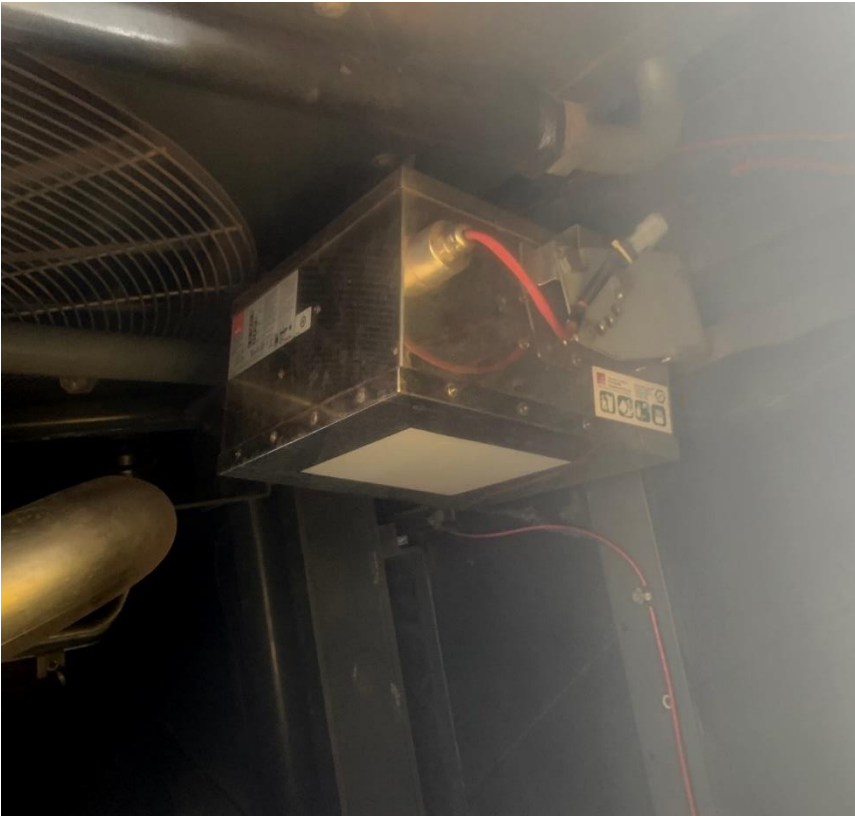
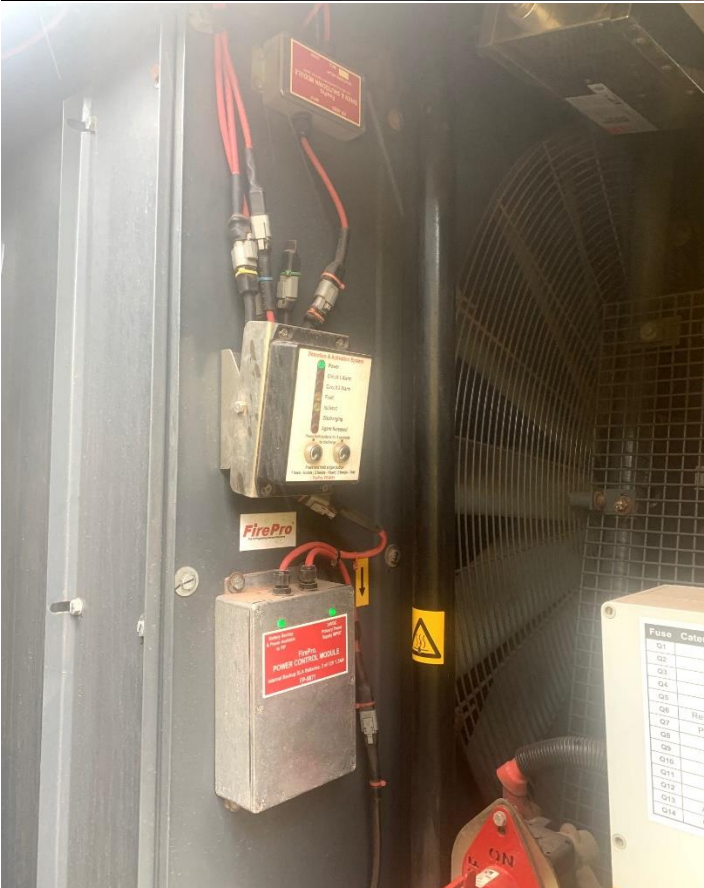
- Resolve mounting location for FP Unit – not as per drawing
- Resolve Mounting Location for Panel – not as per drawing
- Plastic Cover over Control Panel

- Change to NiMH Battery
