Limassol,
16th October 2018

Subject:
Investigation of the FP-5700
malfunction on-board the vessel
“McEwen”

1. Introduction

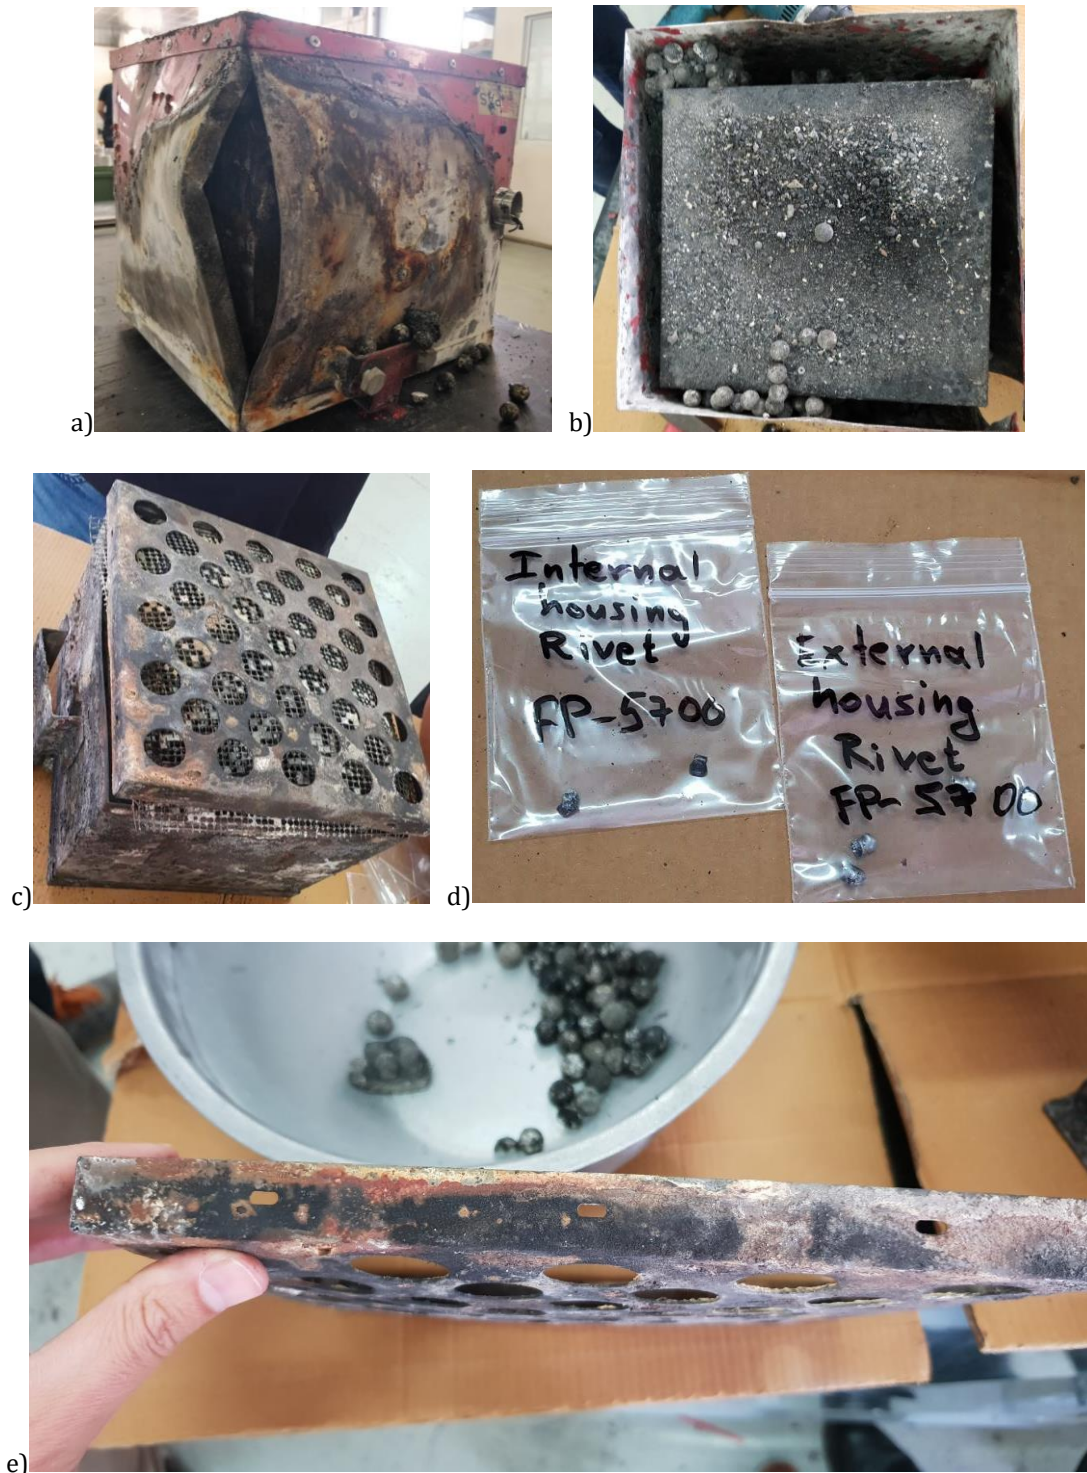
The evidence collected during the preliminary investigation regarding the malfunction of a falsely activated FP-5700 condensed aerosol generator led to the following conclusions, Figure 1:

- The unit (manufactured in April 2016 with serial number 151668) malfunctioned during operation (after activation).
- The malfunction was caused due to failure of the internal housing assembly shortly after the unit's activation and before the end of discharge. The evidence suggests that the rivets securing in place the cover of the internal housing failed unexpectedly during operation. Further investigation would focus on the origin of the rivet failure.
- This phenomenon resulted in flooding the external housing with ceramic spherical cooling material (thus blocking the aerosol's path) causing excessive pressure build-up inside the unit and leading to the breach of the generator's housing.

Figure 1: FP-5700 in-service malfunction; a) Deformed external housing, b) Cooling material observed in the aerosol exit path, c) Internal housing failure, d) Internal and external rivet samples, e) slots on internal housing's plate indicating that there was no resistance from the rivets prior to the plate being detached.

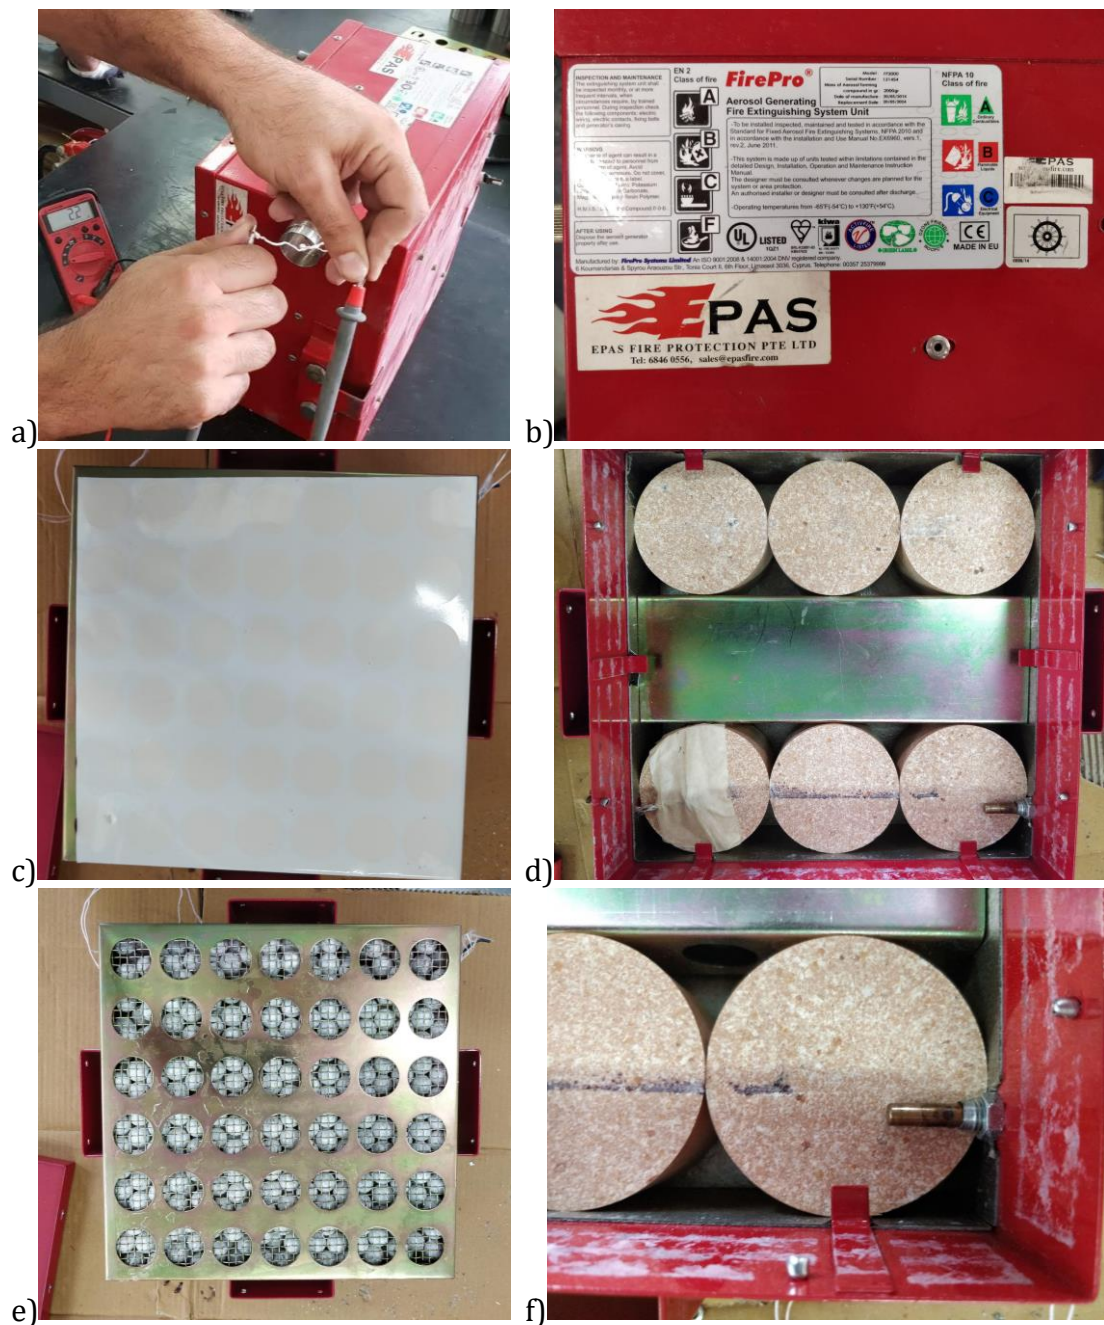
The FP-2000 condensed aerosol generator was disassembled, Figure 2, with the findings suggesting zero environmental factor effect on the generator components and compound.

Figure 2: (a-b)FP-2000 generator, (c-f) FP-2000 disassembled internal housing.

The role of environmental factors in the malfunction of the FP-5700 generator was investigated by assessing the state and performance of the FP-2000 generator installed in the same enclosure:

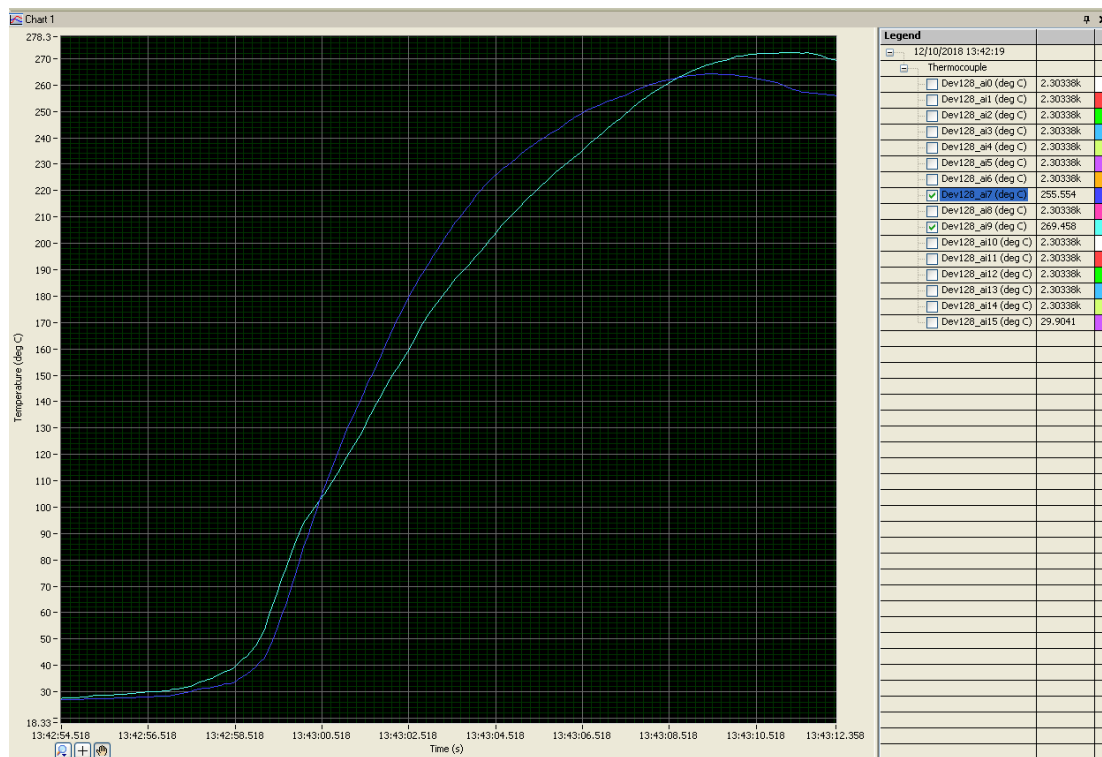
Following the generator`s reassembly, a performance test was run. The FP-2000 generators performed according to its specifications, Table 1 and Figure 3.

Figure 3: FP-2000 performance test - Aerosol temperature at 10 cm from the generator outlets.

FP-2000	R (Ω)	Weight before (g)	Weight after (g)	Efficiency (%)	Discharge Time (s)	Max. Temp at 10cm ($^{\circ}\text{C}$)
131454	2.2	15570	14250	66.0	18	\approx 270
